Manhole Inspection Summary

Manhole # S13II_014MH

Insp Date: **7/21/09 9:30 AM**

Location Address: **REAR 1706 DUKELAND ST**

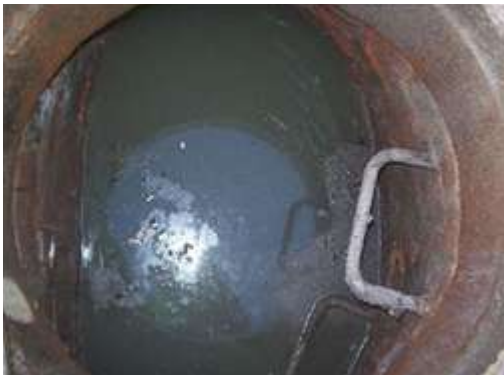
Defect 1

Surcharge ☒ **Evidence Of Surcharge** Depth: **5** (ft.) ☒ **Active Surcharge Present**

ASUR

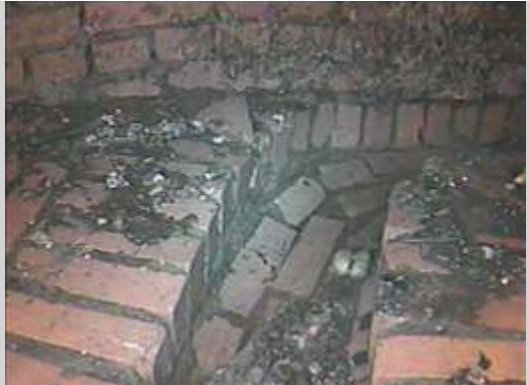
12 O'Clock Outflow

8 in. Circular Gravity Sewer
Pipe Out @ 12 O'Clock

Invert Depth: **6.94** (ft.) Flow Characteristics: **Slow**

Infiltration: **None** Pipe Seal Cond: **Sound**

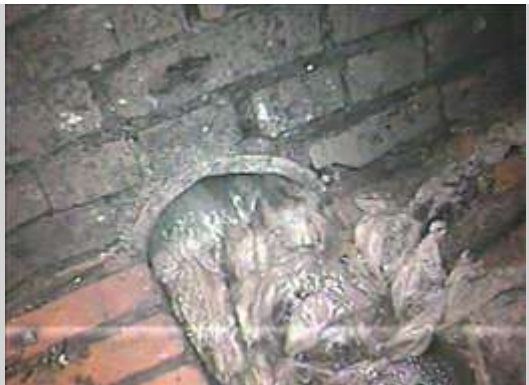
8 O'Clock Inflow

8 in. Circular Gravity Sewer
Pipe In @ 8 O'Clock

Invert Depth: **6.90** (ft.) Flow Characteristics: **Slow**

Infiltration: **None** Pipe Seal Cond: **Sound**
